# Failure investigation of an underground low voltage XLPE insulated cable

Anwar Ul-Hamid, Khaled Y. Soufi, Luai M. Al-Hadhrami and Ahsan M. Shemsi  
Center for Engineering Research, King Fahd University of Petroleum and Minerals, Dhahran, Saudi Arabia

**Paper type** Case study

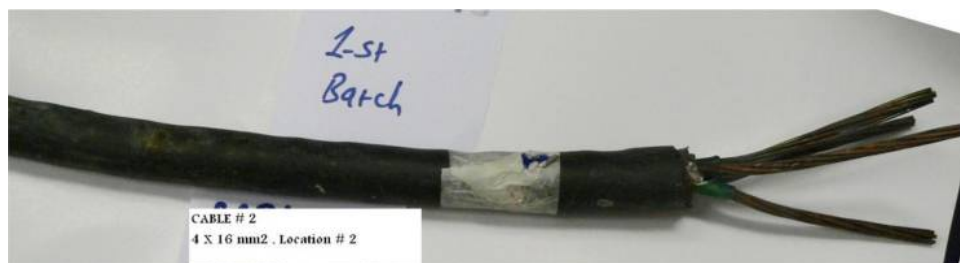
**Figure 2** Typical example of a failed XLPE cable obtained from the site

photographed. A typical example of a failed cable obtained from the site is shown in Figure 2. It was observed that the DST was corroded and was brownish in color. It was fragile and easily breakable. The color of the filler was also brownish and had corrosion traces from the DST. XLPE insulation was darkened and the Cu conductors showed signs of corrosion in the form of spots. The average thickness of the outer PVC jacket of the cables was found to be 2.2 mm. Visual inspection did not reveal any sign of holes, cracks or other defects at the jacket surface. Some discoloration was observed, probably due to exposure to contaminated water and/or aging. Some cable samples without electrical connections had been buried in the sand in an uncontaminated location for a period of 12 months. These unused samples were retrieved and inspected. All cable components were found to be in a good condition unaffected by their environment.

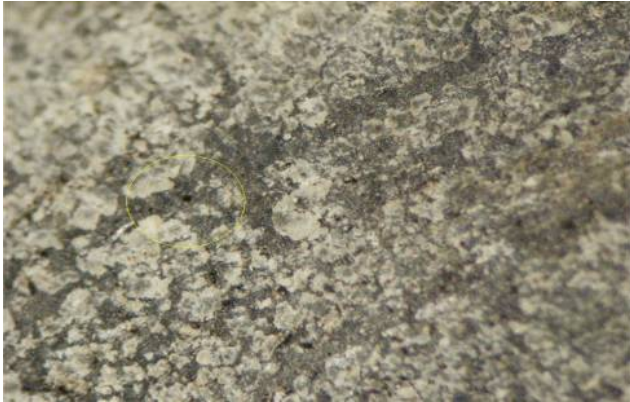
Surfaces and cross-sections of failed and unused cables were examined using light microscopy at low magnifications. The surface of outer PVC jacket of a failed cable is shown in Figure 3. White deposits originating from contaminated water covered the entire surface, while small holes (encircled) were evident in the crevices (Figure 4). A cross-section revealed air/gas bubbles or inclusions in the outer and inner surfaces of the jacket wall. The presence of brown-colored deposit is also clear in Figure 5, indicating penetration of contaminant constituents possibly in solution with water into the jacket material through defects. Eventual evaporation of water had left behind contaminant precipitate.

**Figure 3** Surface morphology showing a hole at the surface of a failed PVC cable (40×)

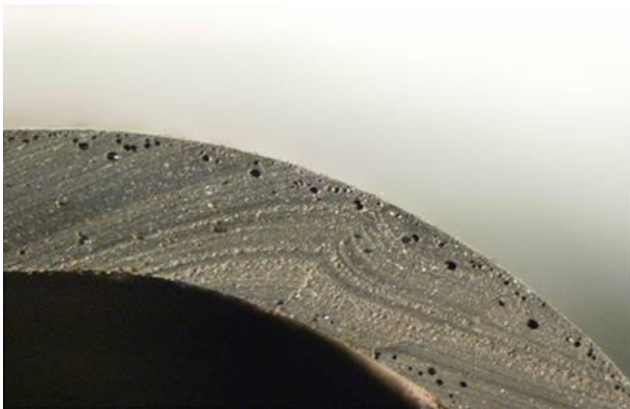
**Figure 4** Cross-section of the outer PVC jacket showing air inclusions at the inner and outer surfaces (18×)

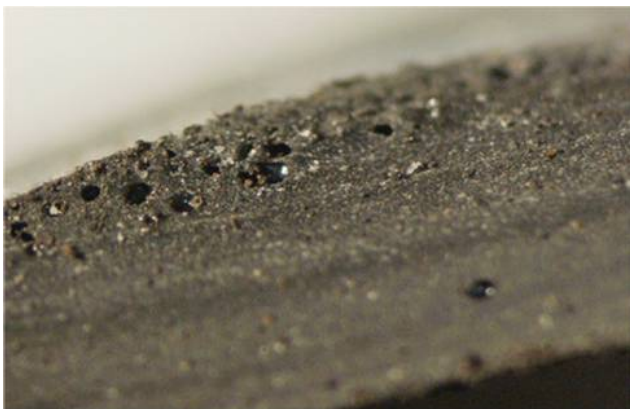
**Figure 5** Cross-section of the outer PVC jacket showing air inclusions and brown-colored contamination (40×)

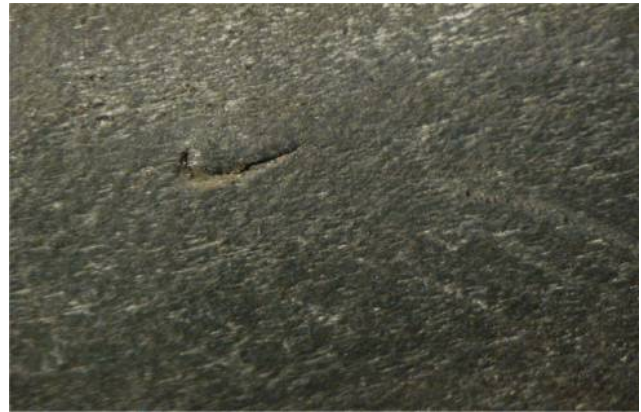
Penetration of contaminated water was further facilitated by the presence of relatively coarse defects such as cracks at the surface, as seen in Figure 6. The presence of brown-colored deposit within the crack is an indication that the crack had been present during service and did not occur during cable retrieval. It may have occurred during cable installation. Cracks can form due to mechanical damage during cable installation. Several cracks that propagated across the jacket wall were observed, as illustrated in a typical example shown in Figure 7. It is clear that water with dissolved contaminants could easily penetrate through these cracks into the inner sections of the cable.

**Figure 6** Relatively coarse crack at the surface of PVC jacket (18×)

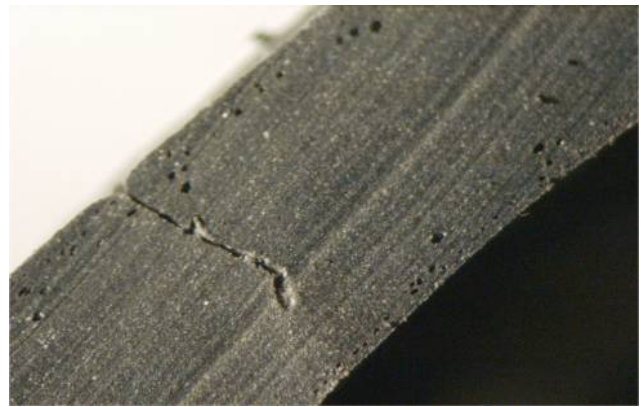
**Figure 7** Cross-section image showing a transverse crack in the PVC jacket (40×)

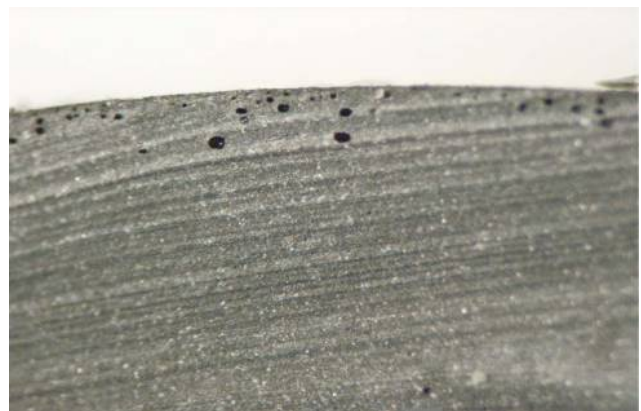
The cracks could originate from defects present within the PVC jacket during manufacturing, installation or service. Figure 8 was obtained from an unused cable similar to the one under investigation in this study and served to highlight the existence of manufacturing defects. Air inclusions were found close to the outer and inner surfaces of the PVC jacket. These

inclusions were formed during the extrusion process when the insulated cable was covered with the PVC jacket.

**Figure 8** Cross-section of unused cable showing air inclusions at the inner and outer surfaces of the PVC jacket (18×)

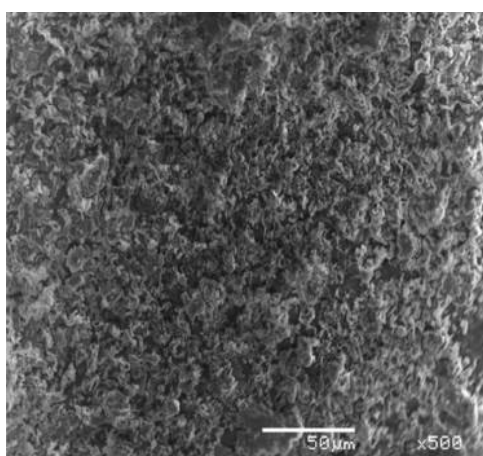
Figure 9 Secondary electron SEM image of the deposit seen at the inner surface of PVC sheath in the failed cable

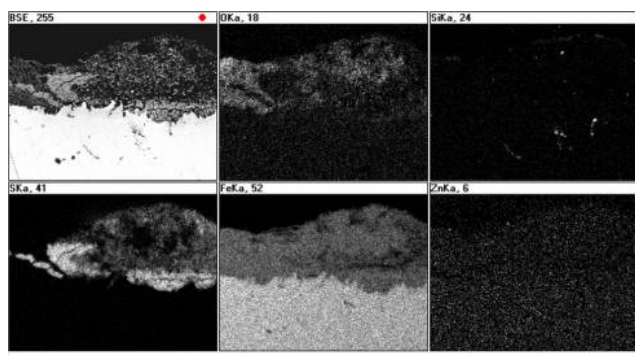
shown in the X-ray mapping images of Figure 10. Sulfur was detected within the filler material and also within the inner surface of the XLPE material, as shown in Figure 11. In the SEM images, sulfur existed as small bright deposits on top of a layer of Cu present on the XLPE inner surface. During visual inspection, this deposit appeared as a black layer within the inner XLPE surface. The outer surface of the XLPE was blackened and showed the presence of Cu. Moreover, the presence of Fe and O at the metal surface suggests the formation of an Fe-oxide compound. The blackened region of the Cu wire in the failed cable also was analyzed and was found to contain significant amounts of S and O. Sulfur could originate from sand, as the latter showed the presence of S in chemical analysis (Table II). Elevated seawater table is the most likely source of sulfur in sand, as seawater contains appreciable amounts of sulfates. Seawater in the study area floods the cable trenches frequently. Foreign material observed within the cable is thought to originate from the surrounding sand environment.

Figure 10 X-ray map images obtained from a cross-section of metal armoring of the failed cable showing the presence of S within the deposit present at the surface of metal

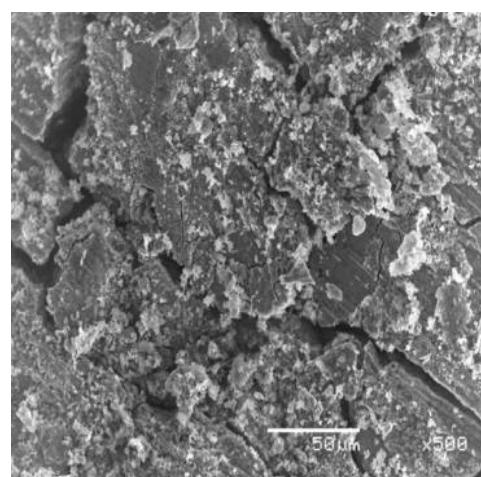
Figure 11 Secondary electron SEM image of the deposit observed at the inner surface of XLPE insulator material in failed cable

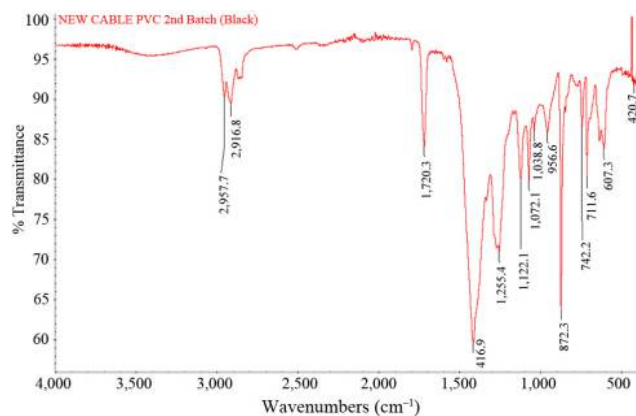
In Figure 12, the characteristic FTIR spectrum of pure PVC is given for reference and analysis. This spectrum shows all group frequencies matched with the given frequencies in Table IV. The encircled region in Figure 12 shows no clear peak but does exhibit a little kink. Figure 13 shows the FTIR spectrum of an unused cable. This cable showed all the characteristic peaks of PVC. Closer inspection revealed that there were small changes occurring in the band at 1,720 cm<sup>-1</sup>. This band can be attributed to the carbonyl stretching (CO-stretching 1,720 cm<sup>-1</sup>). This is an indication that dehydrochlorination occurred during manufacturing or storage of the cable.

**Figure 13** FTIR spectrum of the outer PVC jacket of new cable No. 9

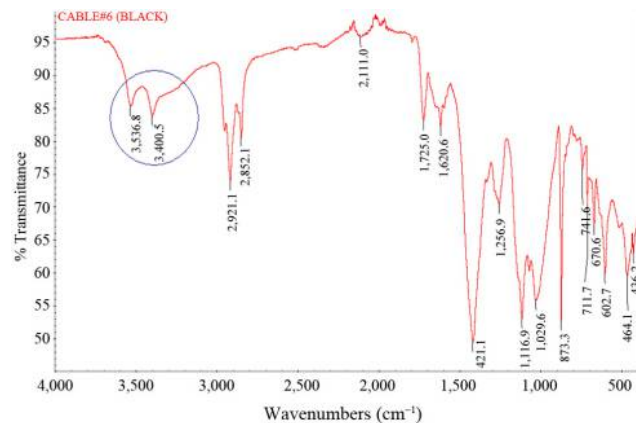
The spectra of failed cables (see the typical example shown in Figure 14) exhibited group frequencies similar to those stated for PVC. They also showed a band at 1,720 cm<sup>-1</sup>, an indication of the aging process, and a broad band between 3,500–3,200 cm<sup>-1</sup>, showing the presence of hydrated water. Some cables showed two sharp bands in this region, indicating

an N-H stretching vibration of the nitrogen-containing compound present as monoamine in the PVC, which could be attributed to the effect of ammonia contamination on the cable jacket (Brenntag Canada Inc, 2014).

**Figure 14** FTIR spectrum of the outer PVC jacket of failed cable
