# Failure investigation of an underground low voltage XLPE insulated cable

Anwar Ul-Hamid, Khaled Y. Soufi, Luai M. Al-Hadhrami and Ahsan M. Shemsi  
Center for Engineering Research, King Fahd University of Petroleum and Minerals, Dhahran, Saudi Arabia

**Paper type** Case study

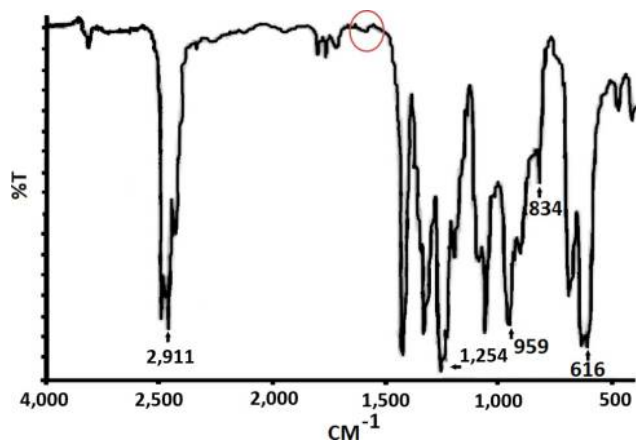
**Figure 12** FTIR spectrum of a pure polyvinylchloride (PVC)

In Figure 12, the characteristic FTIR spectrum of pure PVC is given for reference and analysis. This spectrum shows all group frequencies matched with the given frequencies in Table IV. The encircled region in Figure 12 shows no clear peak but does exhibit a little kink. Figure 13 shows the FTIR spectrum of an unused cable. This cable showed all the characteristic peaks of PVC. Closer inspection revealed that there were small changes occurring in the band at 1,720 cm<sup>-1</sup>. This band can be attributed to the carbonyl stretching (CO-stretching 1,720 cm<sup>-1</sup>). This is an indication that dehydrochlorination occurred during manufacturing or storage of the cable.
